THE POTENTIAL IMPACT OF A FLOATING TIRE BREAKWATER
ON AREA WATER QUALITY AND FISHERY RESOURCES

IN PRESQUE ISLE BAY

FINAL REPORT - July 1983

Lake Erie Institute for Marine Science

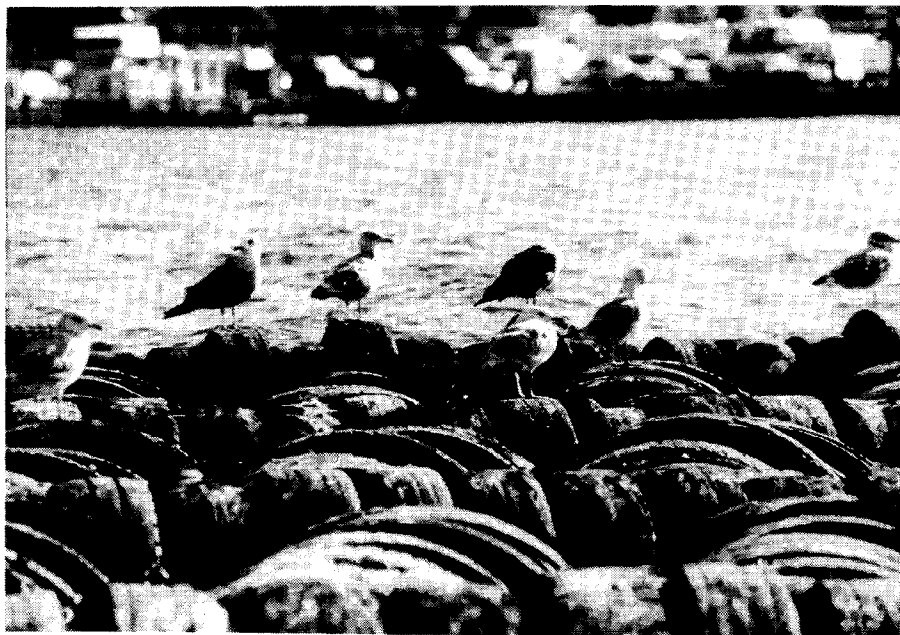
Figure 7. Sea gulls perched on a segment of the FTB.

Habitat for sea gulls observed. (See Figure 7)

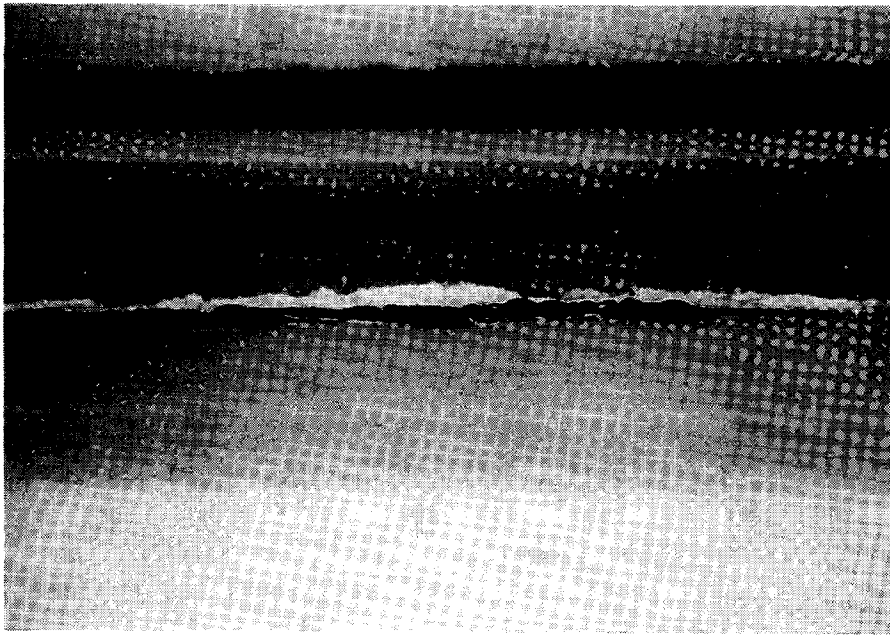
Feb. 1983 - FTB locked in ice.

Figure 8. FTB locked in ice with ice dunes formed on leading edge.

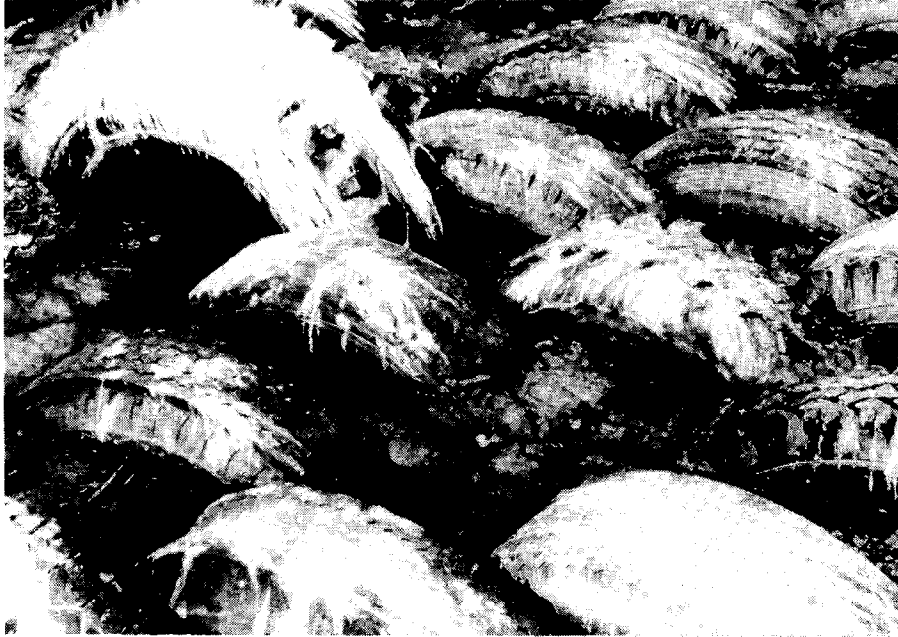
June 1983 - Algae reaches peak growth, ducks begin to congregate and game fish are observed around structure. (See Figure 10)

Figure 10. Algae growth on the tires in early June 1983.

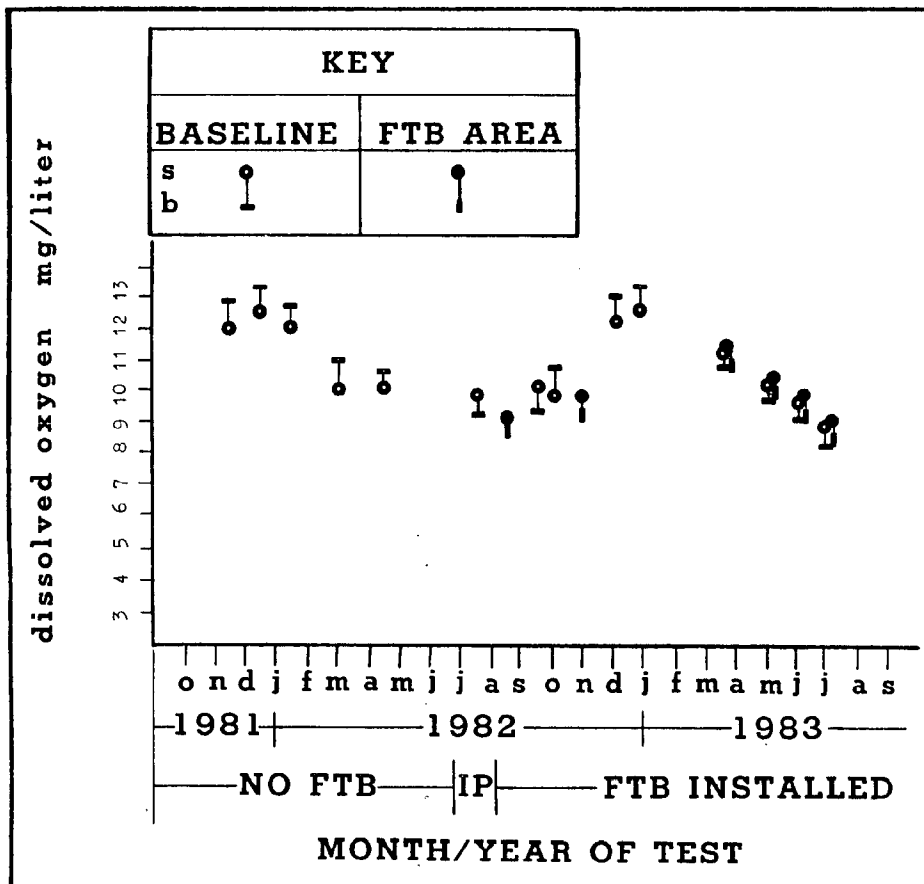
FIGURE 12

A plot of representative dissolved oxygen (DO) versus month/year of testing is presented in Figure 12. The DO ranged between a high of 13.4 and low of 8.2 with higher values occurring when the water was colder and the lower values occurring during the summer months. In the vicinity of the breakwater, the DO values appeared to be higher at the surface. In general there appears to be no significant difference between data in the FTB area when compared with the baseline area.

CHANGE IN DISSOLVED OXYGEN PROFILE
DURING STUDY PERIOD

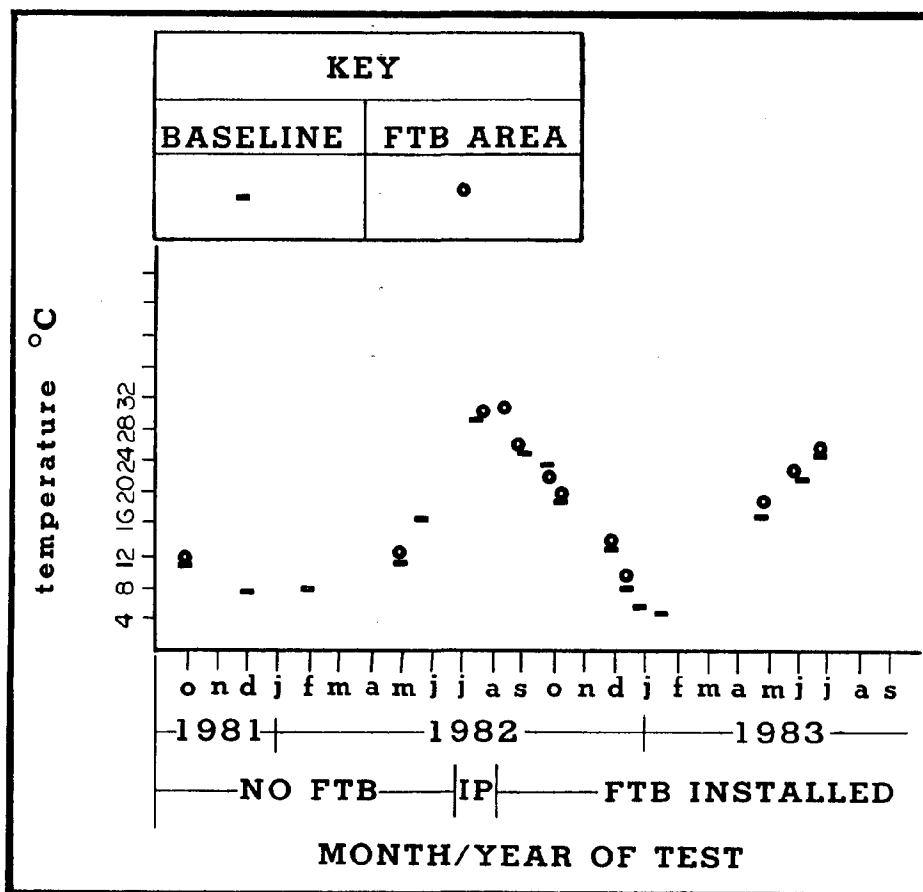
FIGURE 13

A plot of representative water temperature data taken during the study period are shown in Figure 13. The data reflect the normal seasonal temperature variations. Overall, there was no detectable difference between the water temperature in the vicinity of the FTB versus the baseline. However, not shown in Figure 13 is the observation that during the middle of June 1983, a series of five sunny, warm days occurred. During this period it was observed that the water temperature at the bottom under the FTB was 3 degrees centigrade lower than at the top water layers within the FTB structure itself. The baseline temperature (top and bottom layers) did not show this large top to bottom temperature difference. It has been concluded that the FTB provides an aquatic shading effect. The sun cannot penetrate the FTB structure to warm the bottom

WATER TEMPERATURE PROFILE IN VICINITY
OF FTB COMPARED TO BASELINE

layers of the water. There is therefore a lag in the rate of heating of the water under the FTB by the sun under the FTB. Such an effect is most likely dynamic and due to diffusion and water circulation.

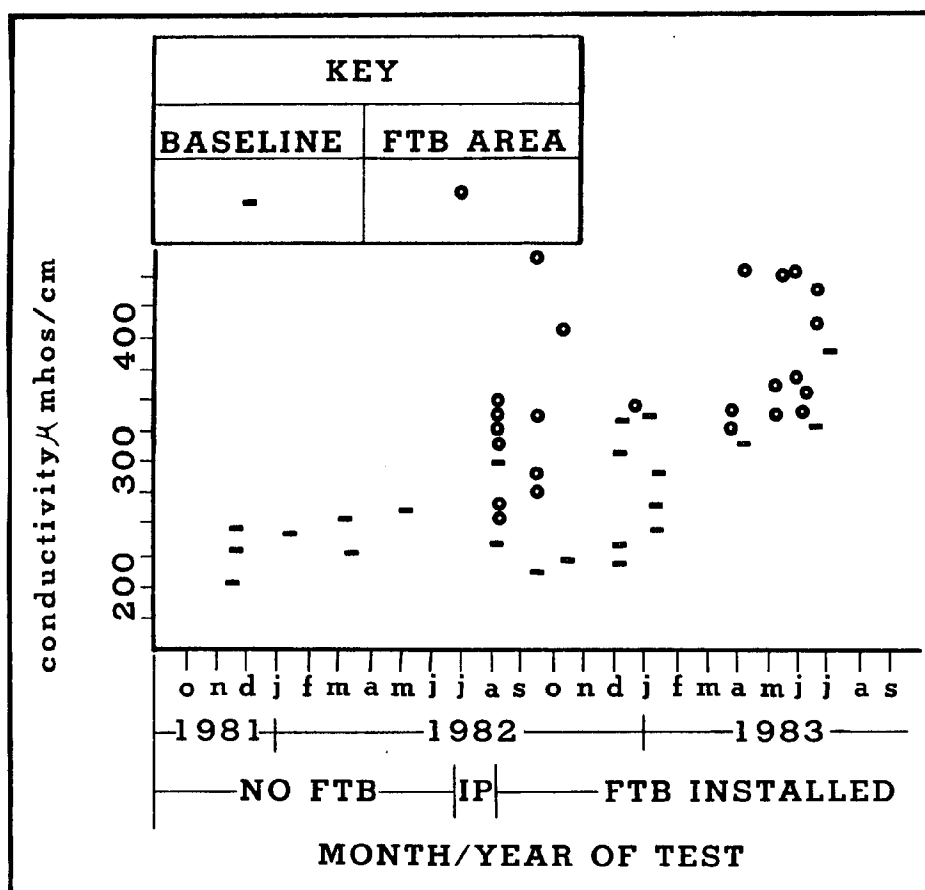
FIGURE 14
ELECTRICAL CONDUCTIVITY PROFILE IN VICINITY
OF FTB RELATIVE TO BASELINE

Representative data showing the variation of electrical conductivity of the Presque Isle Bay waters during the test period are shown in Figure 14. The electrical conductivity of aqueous media is a very sensitive measurement, almost too sensitive to interpret with any confidence. The subject electrical conductivity measurements can be interpreted as an indication of the amount of dissolved ions (electrolyte) in the water. From this, it was observed that the measurements taken during the initial installation period (August to October 1982) indicates a higher electrical conductivity of the waters around and in the FTB location compared to the electrical conductivity of the "baseline" waters. As indicated by Figure 14 the baseline conductivity during the August - October 1982 period was 200 to 280 μ mhos/cm. In the vicinity of the FTB during the same period, the conductivity of the water ranged from 250 to 500 μ mhos/cm. It is felt that this is a real difference in spite of the wide scatter of the data. One explanation could be that electrolyte is being leached out of the scrap tires in the FTB structure. It is possible that road salt from the tires and

alkaline (lime) minerals from the rubber belting used in the construction of the FTB is being dissolved out of the material. This speculation is somewhat supported by the observation that at present (spring and summer 1983), the electrical conductivity of the waters around the FTB and the baseline are similar. There is now no difference suggesting that during the winter months this electrical conductivity difference effect has dispersed itself by the natural dynamics of the wind/wave/current action of the Presque Isle Bay waters.
